**Flood Control Project Maintenance
Levee Inspections**

Fall 2013 Levee Maintenance Deficiency Summary Report

Sacramento River Basin

California Department of Fish and Game Shea Levee

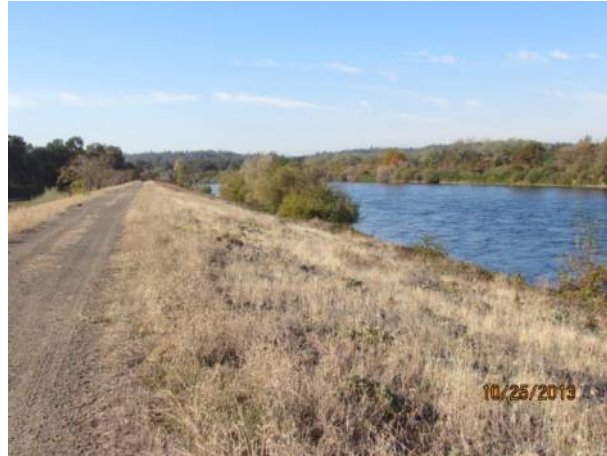
Levee Mile Report Line	4
Start Levee Mile	0.00
End Levee Mile	0.28
Location	Water Side
Category	Earthen Levee
Item	Vegetation
The Department of Fish and Wildlife service has done no maintenance.	
rduffey_f_20131104_134.JPG

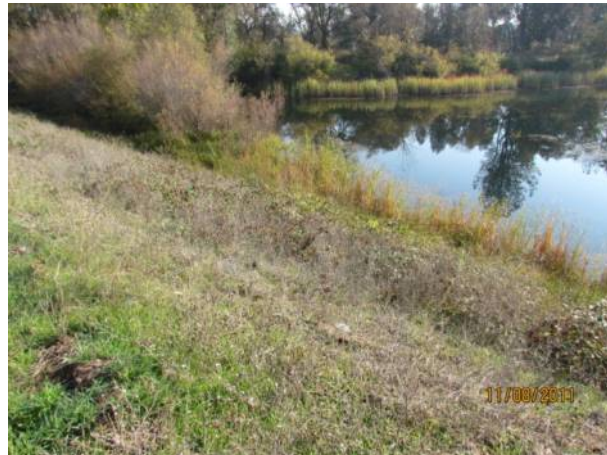
Levee Mile Report Line	5
Start Levee Mile	0.02
End Levee Mile	0.06
Location	Land Side
Category	Earthen Levee
Item	Vegetation
View of the berry vines along the L/S slope.	
rduffey_f_20130919_001.jpg

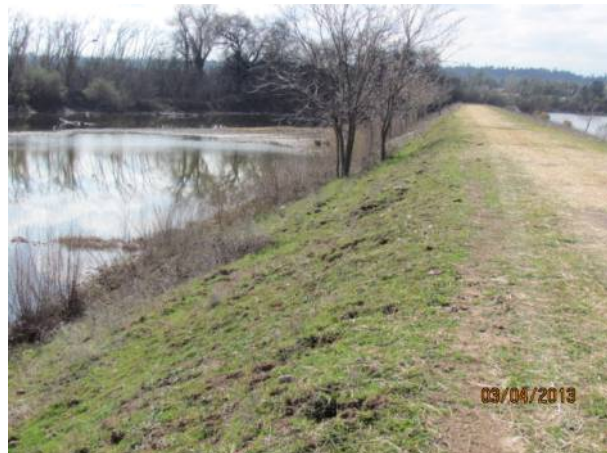
DWR ID: DWR_NA0018_01_s_2012_1										
6	0.02	0.08	Earthen Levee	Animal Control	LS Ma	M	A2 : Repair the levee slope damaged by livestock and prevent large animal access. Inspector Comments: The livestock damaged the L/S slope.	40.511185 ° 122.360553 °	40.510671 ° 122.360944 °	6 Y
DWR ID: DWR_NA0018_01_s_2013_6										
7	0.06	0.20	Earthen Levee	Trim / Thin Trees	LS Ma	M	T2 : Thin trees to allow visibility of the ground and room to flood fight.	40.510649 ° -122.360945 °	40.509012 ° -122.362609 °	9 Y
DWR ID: DWR_NA0018_01_f_2012_9										
8	0.08	0.21	Earthen Levee	Vegetation	LS Ma	M	V2 : Remove the wild growth other than native grasses from the levee slopes.	40.510671 ° -122.360944 °	40.509146 ° -122.362499 °	5 Y
DWR ID: DWR_NA0018_01_s_2012_5										
9	0.25	0.30	Earthen Levee	Vegetation	LS Ma	M	V2 : Remove the wild growth other than native grasses from the levee slopes.	40.508138 ° -122.363480 °	40.508138 ° -122.363480 °	2 Y

Levee Mile Report Line	6
Start Levee Mile	0.02
End Levee Mile	0.08
Location	Land Side
Category	Earthen Levee
Item	Animal Control
View of the livestock erosion along the landside slope.	
rduffey_f_20130919_004.JPG

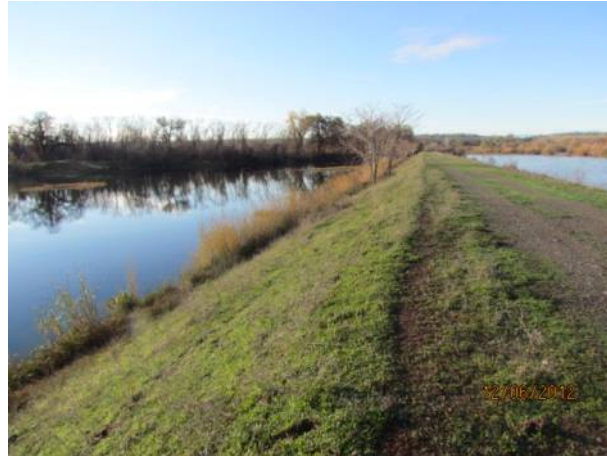
Levee Mile Report Line	7
Start Levee Mile	0.06
End Levee Mile	0.20
Location	Land Side
Category	Earthen Levee
Item	Trim / Thin Trees
Remove the small trees along the landside slope.	
rduffey_f_20130919_005.JPG

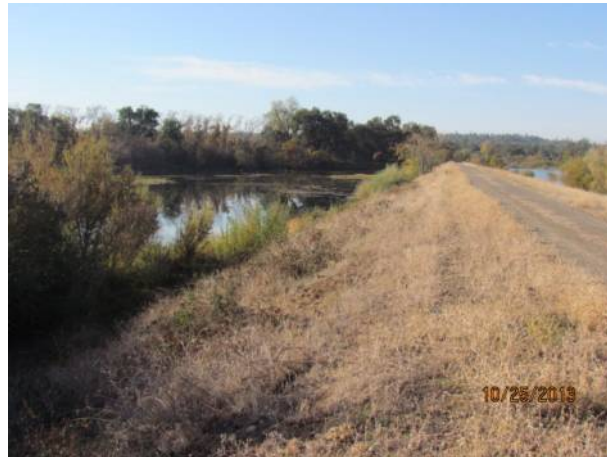
Levee Mile Report Line	8
Start Levee Mile	0.08
End Levee Mile	0.21
Location	Land Side
Category	Earthen Levee
Item	Vegetation
The Department Fish and Wildlife Service has done no maintenance this year.	
rduffey_f_20131104_135.JPG

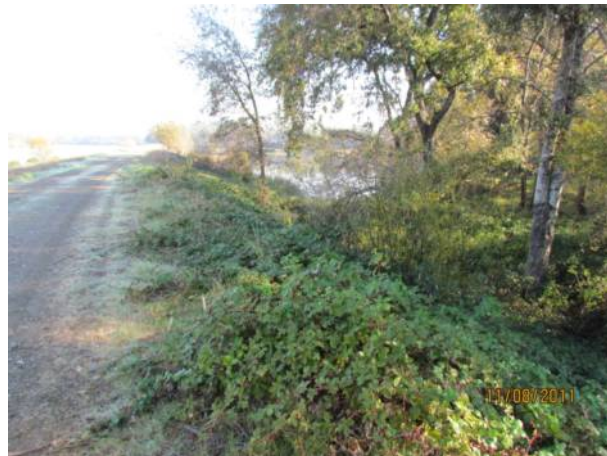
Levee Mile Report Line	9
Start Levee Mile	0.25
End Levee Mile	0.30
Location	Land Side
Category	Earthen Levee
Item	Vegetation
View of the vegetation along the L/S slope.	
rduffey_f_20130919_002.jpg
